# EFFLUENT MANAGEMENT PRACTICES IN REREWHAKAAITU, ROTOMAHANA AND OKARO LAKES CATCHMENTS

This paper summarises the findings of land application of effluent from either dairy sumps or storage ponds through five different application delivery systems. These measurements provide data on effluent spreading distribution, application depth, concentrations of major nutrients and nutrient loadings.

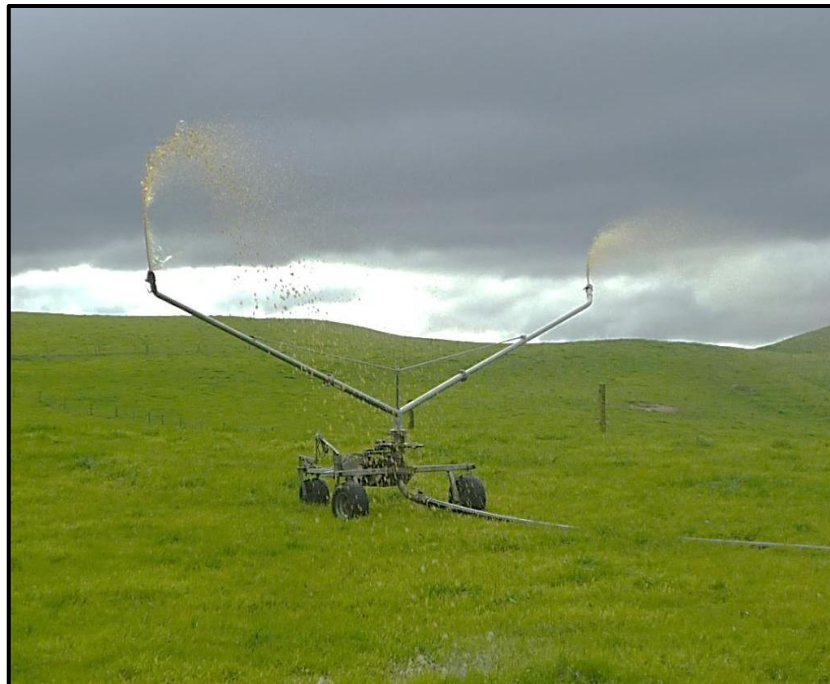
**Figure 2:** Siphoning effect from stationary irrigator below storage pond.

- A 'siphoning effect' was observed on one farm where the travelling irrigator was spraying in a paddock below the height of the storage pond. Once its run had finished the FDE continued to exit the stationary irrigator in a 'geyser-like' effect (Figure 2). All the FDE in the delivery hoses could potentially empty in this fashion creating a nutrient 'hot spot'. This situation could be remedied cheaply by installing a T-valve close to the pond pump. When FDE is being pumped, the flow keeps the valve shut. When the pumping stops, there is no pressure and the valve opens letting in air. When there is an air gap in the line no siphoning will occur and the FDE only drains from the pump to the pond (Gene Roberts, dairy farmer, pers. comm.).

However, in some cases this can be an excessive amount of FDE, so the use of a leakage eliminator at the irrigation equipment means that once the optimum pressure required for the delivery system to operate effectively drops, the flow is shut off. This, combined with taps at the hydrants, limits any unwanted spillage.

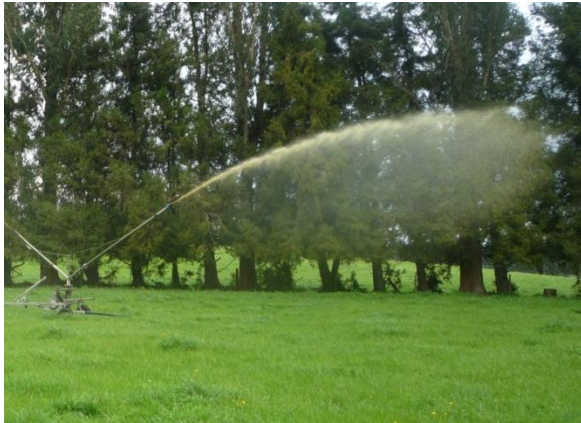
**Figure 3:** FDE being sprayed correctly.

- When the pump is not capable of providing enough pressure and flow due to not being matched correctly to the effluent delivery lines and irrigation equipment, it will result in the FDE being squirted onto pasture rather than being sprayed (Figures 3 and 4). This result is usually seen in a 'donut' form of irrigation with much higher application depths on the periphery of the circle. The spreading width also tends to be narrower than normal for the delivery system, and excessive ponding can result.

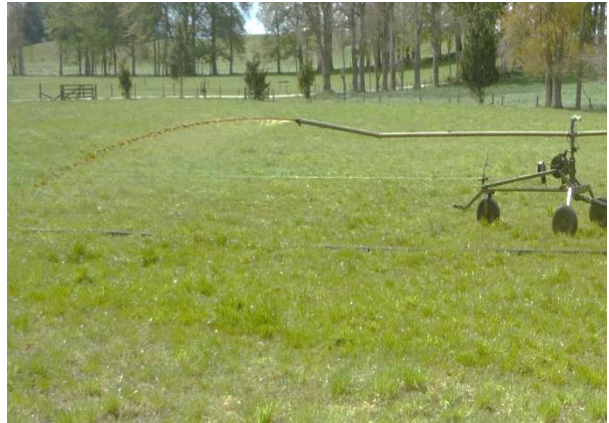
**Figure 4:** FDE being squirted incorrectly.
