# EFFECTIVENESS OF CONSERVATION TREES IN REDUCING EROSION FOLLOWING A STORM EVENT

## Summary

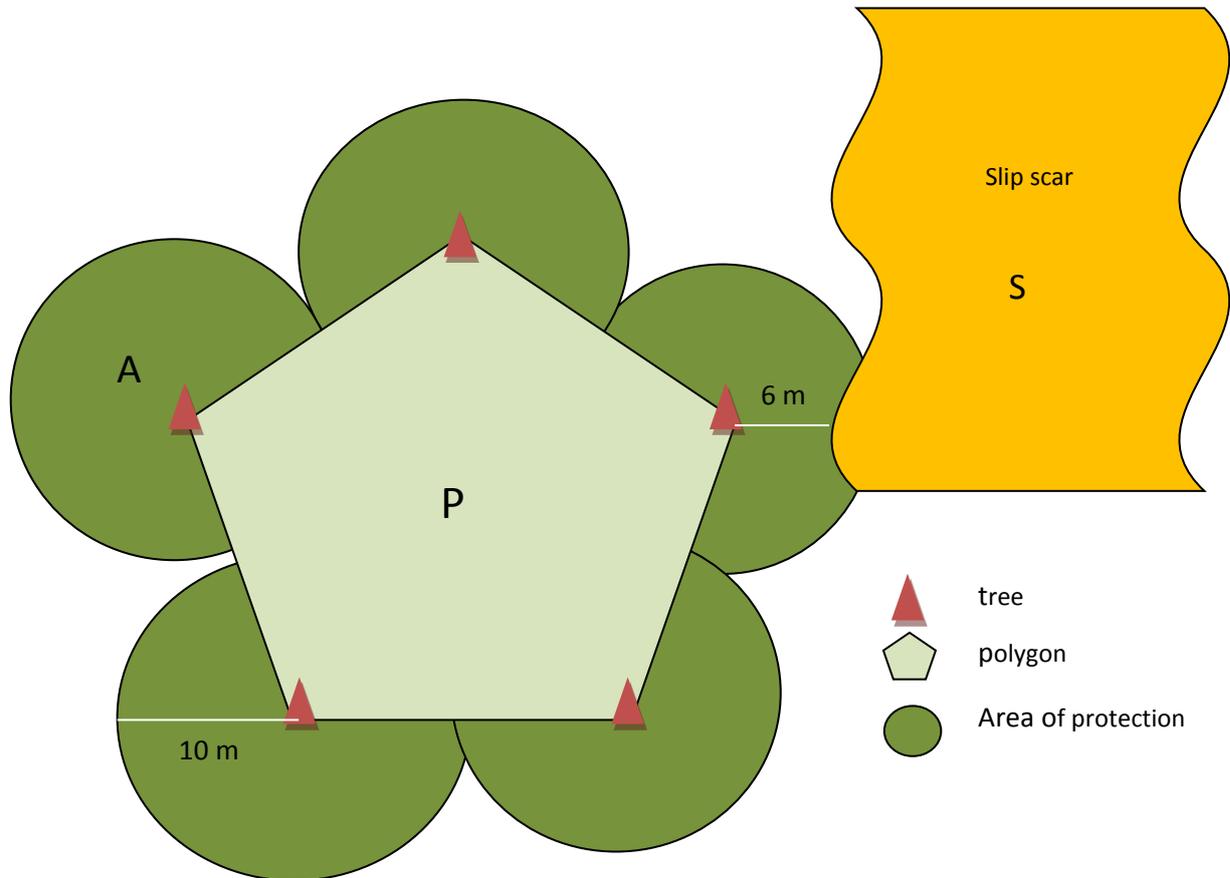
**Figure 2** Diagrammatic representation of the total protection afforded by a treed site. The polygon (P) is shown as light grey area, and the area of protection (A) is shown as green. Any intersection areas were only counted once. Total protection area (T) is all the shaded area excluding the slip. Where the slip scar (S) approached closer than 10 m, that distance was used as the radius of protection (in this diagram it is 6 m).

The distances to all other trees (m) within the group of trees at that site were measured and recorded. Using these measures, the polygon (P - area of the site bounded by the trees) was calculated. The area of protection (A) for a treed site was calculated as the sum of the circular protection areas around each tree (using a radius of protection of 10m) excluding those fractions of the areas already contained within the polygon (Figure 2). Ten metres was taken as a proxy radius of protection as found by Douglas et al. (2013), unless the distance to the slip was less than 10 m, in which case the lesser distance was used. The area (S) of any slip scar present within the polygon was subtracted from the polygon. The area of the slip and the slope of the slip were calculated only if the slip was within 15 m of the treed site. Measurements were also taken at sites where there were trees planted and where there was no notable slipping but where there was ground disturbance such as cracks opened up, or an upward advance of the gully.

Total area of protection (T) for a treed site was calculated using the following formula:

$$T = A + P - S$$

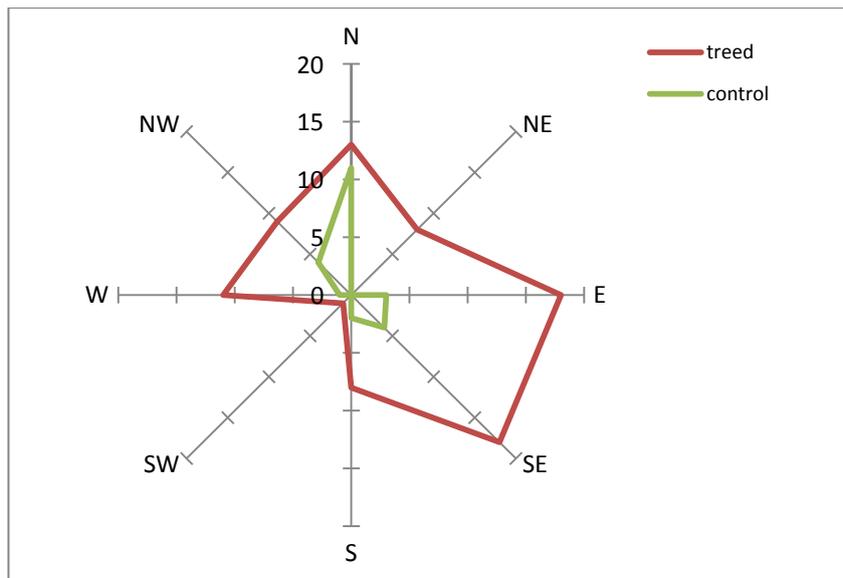
**Figure 3** Distribution by site aspect of treed sites (N = 86) and control sites (N = 25).

The treed sites favoured E and S facing aspects (Figure 3). The majority of the control sites were N facing. Slipping from the storm was not noticeably directional, as determined from aerial photomaps taken immediately following the storm.

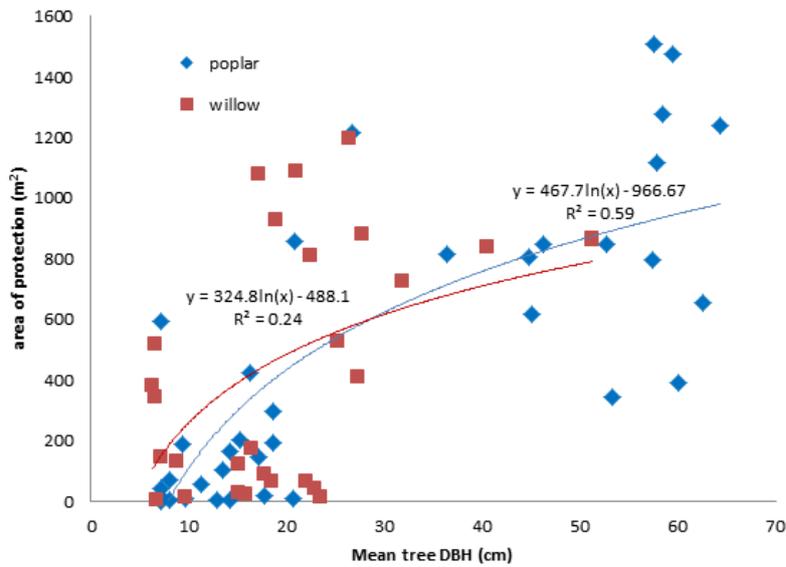
**Figure 4** Area of protection for each site compared against the mean DBH of the trees present at the site separated for species (N = 32, poplar; N = 24, willow). Both data sets are fitted with a log model.

When the area of protection was compared with the mean tree DBH, a logarithmic function fitted the data for the poplars moderately well ( $R^2 = 0.59$ ), whereas it was a poor fit of the data for the willow sites ( $R^2 = 0.24$ ) (Figure 4). For the three poplar outlier sites with mean DBH  $>40$  cm and furthest below the trend line, a low area of protection could be accounted for at each site. Two of the three sites were gully plantings with the side slopes exposed resulting in slipping close to the sites. The site with the least protection (53, 344) was on the steepest measured slope of  $34.9^\circ$  (mean). There were only three trees present at the site and cracking was present inside the polygon. If the outliers were removed the model has a better fit with  $R^2 = 0.76$ . These data do not consider the number of trees at the site which, in turn, influences the area of protection. When the pattern of protection is allocated on a per tree basis for each site (Figure 5), again the data are a moderately good fit for poplar ( $R^2 = 0.64$ ) but a poor fit for willow ( $R^2 = 0.33$ ).

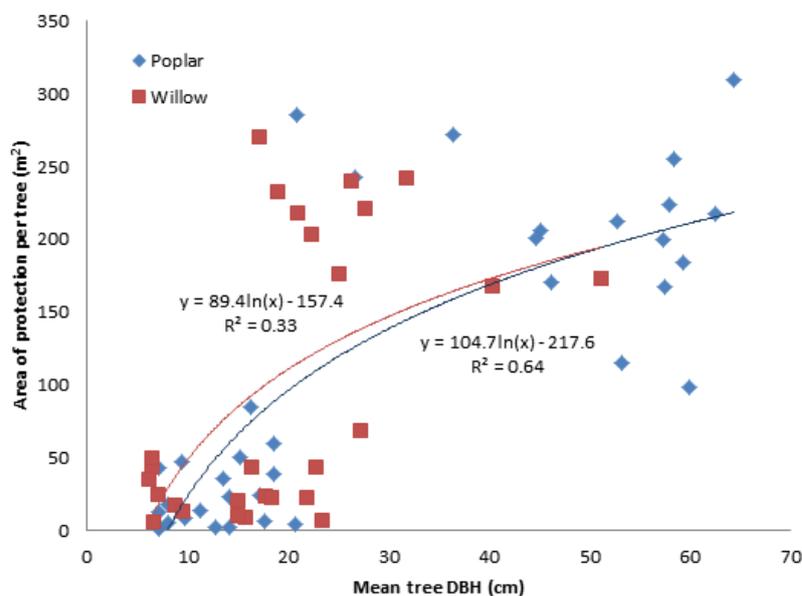
**Figure 5** Area of protection per tree at each site compared with mean tree DBH (N = 32, poplar; N = 24, willow). Both data sets are fitted with a natural log model.

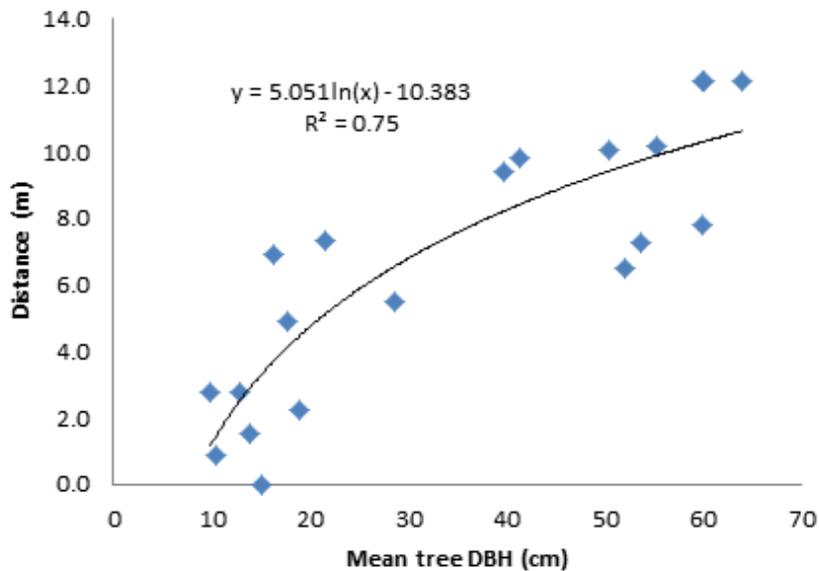
**Figure 6** Relationship between DBH of the closest tree to a slip (at a treed site) and distance from that tree to the slip edge (N = 19). Data are fitted with a natural log model.

If a slip was present adjacent to a treed site then the distance from the slip to the nearest tree was measured and this was plotted against that tree's DBH (Figure 6). As the DBH of the nearest tree increases so does the distance to the slip, which fits strongly ( $R^2 = 0.75$ ) with the natural logarithmic model (Figure 6). This further supports the findings of Douglas *et al.* 2013 as the distance begins to level at ~10m.

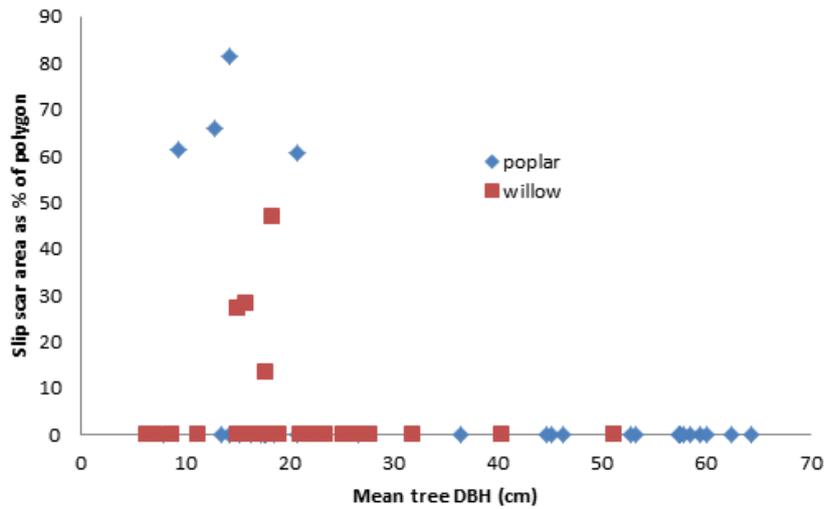
**Figure 7** Slip scar area within the tree polygon as a % of the polygon area (see text for how this was calculated) for treed sites (N=60).

Where slips originated within the area bounded by trees planted for soil conservation (Figure 7) it was apparent that groups of trees where the mean DBH was  $\sim \leq 20$  cm were not able to hold the soil. This analysis does not consider spacing between the trees or the number of trees in the group. The closer trees are to each other the greater the degree of root overlap between adjoining trees and the greater the root reinforcement of the slope. For the 4 groups of willows in Figure 7 where both the mean DBH was  $\sim \leq 20$  cm and slipping occurred within the polygon, the spacings (mean DBH, no. of trees) were 7 (15.1, 6), 7.3 (17.8, 4), 8.1 (18.4, 3) and 18.2 (15.8, 3) m. For the 4 groups of poplars in Figure 7 where both the mean DBH was  $\sim \leq 20$  cm and slipping occurred within the polygon, the spacings (mean DBH, no. of trees) were 3.9 (12.8, 3), 7 (20.7, 2), 14.5 (14.2, 3) and 18.8 (9.4, 4) m. The wide variation in tree spacings may be due to tree deaths in the first two years, or differences in landowner approaches to tree placement. While tree deaths are the more likely explanation, the benefits of having other trees close by when trying to reduce slipping may not always be understood by landowners.

For the 60 sites shown in Figure 7, the mean number of trees present per site was 4.3 with a mean spacing between trees of 11.2 m. The data suggest that smaller trees (DBH < 20 cm) are more likely to be uprooted by slips, and when they are present in smaller groups. Young trees that have died should be replaced to maintain the original root reinforcement plan for stabilising the soil. The rate of growth (of the root system) of poplar and willow trees on slopes is much slower than on the flat, being reduced by shallower soil depth, less water availability and often increased wind run.

Considering both Figures 7 and 8 (data from same sites), effectiveness of conservation trees in reducing slipping reduced at high tree spacings and when the trees are young (even at low tree spacings). Whereas mature poplar and willow trees are able to resist slipping and reduce the impact of slip debris (Figure 9, upper photos), smaller trees may have limited effectiveness ((Figure 9, lower photos; Figure 10). This is largely attributed to the root system not having the extension to bind soil, or the individual root strength supported through thickness, branching and sinker roots, to resist distortion through soil slipping. However, holding saturated soil can be challenging, even to a dense root network (Figure 10, right).

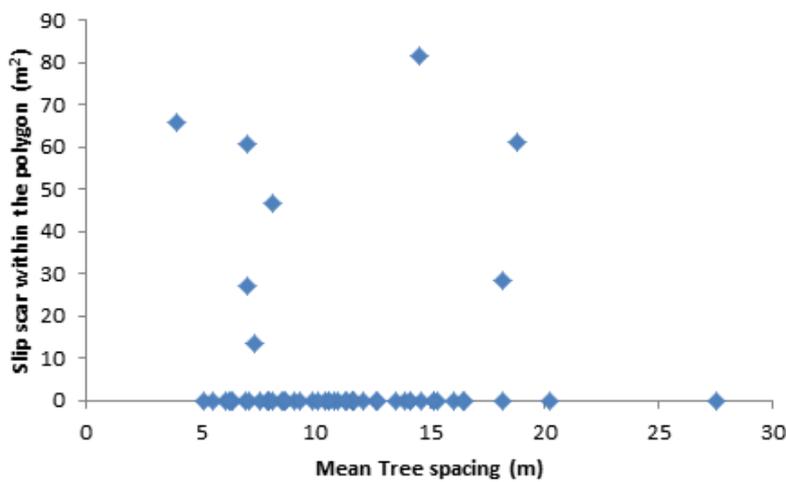
**Figure 8** Relationship between slip scar area within treed site polygon and the tree spacing (N = 60).

Of the 60 treed sites, only 8 (13.3%) experienced slipping. Figure 8 inform why there are sites with trees and also with slipping, because there is no information on tree size. Perhaps it is not surprising that where trees are 15-20 m apart the protection is insufficient to prevent slipping. Slipping at spacings of 4-8 m occurred where the mean DBH of the trees was <20 cm (see Figure 7).

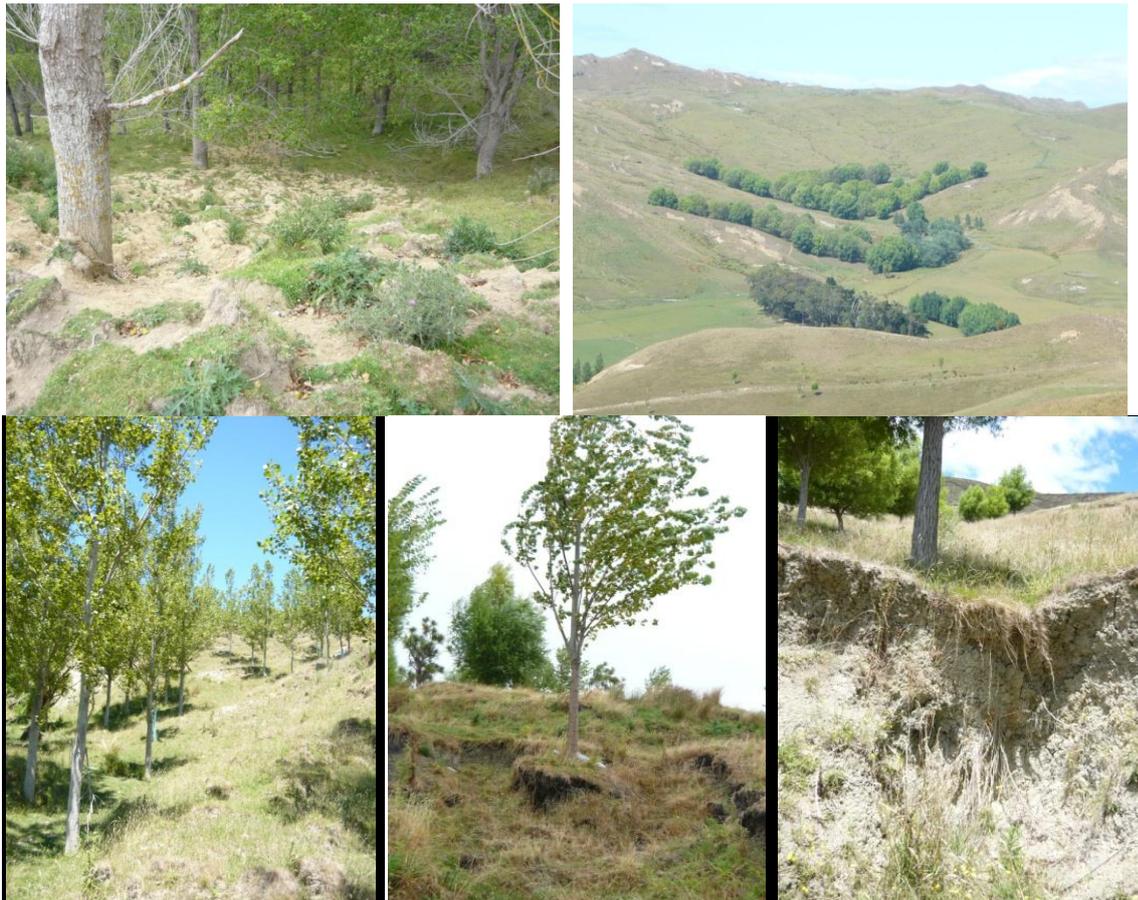
**Figure 9** Mature poplar and willow plantings located on lower slopes (upper left); or in gullies (upper right). Younger willow and poplar planted for a mixture of slope and gully protection (lower left, centre); but with a weakly developed root system showing limited capacity to resist slipping or gullyng (lower centre, right).

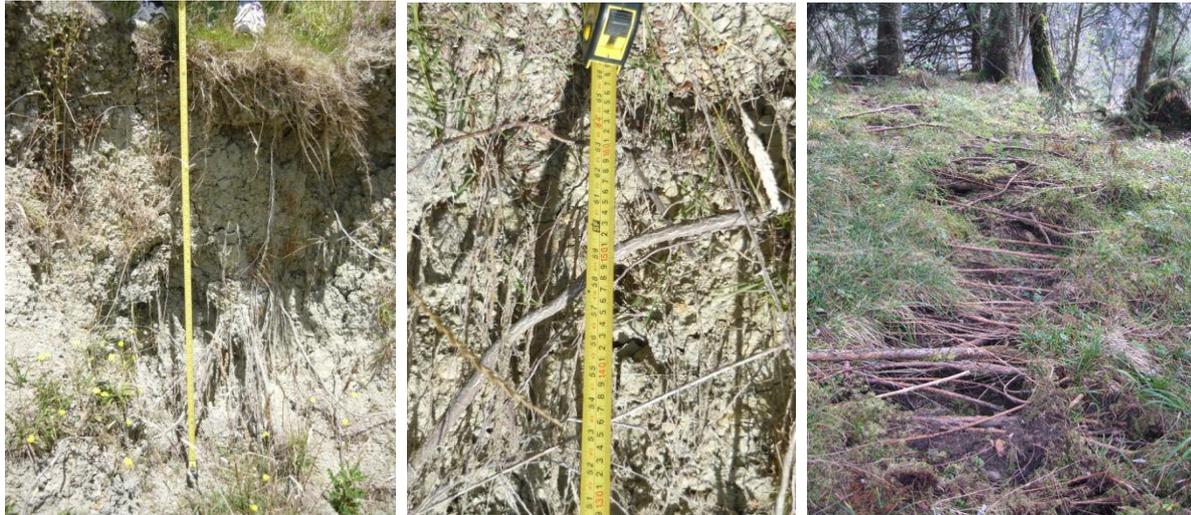
**Figure 10** Gully head erosion interrupted by roots of a young willow (Left); contributed by the mass of fine roots developed in a moist environment (Centre). Rooting depth was 170 cm. Even dense forest tree root networks may not prevent slipping, but will reduce its severity (Right) (Photo M Schwartz).

Data presented in the results were largely from slope plantings. However, where young (mostly) willows were planted in or close to gullies, the greater soil depth and availability of soil moisture enabled the trees to develop a deeper and more extensive root system after ~3 years which often interrupted advancement of the gully, even though the root system was usually exposed (Figures 9 and 10). Slipping occurred but its severity was reduced sufficiently that the trees providing the protective measures remained largely intact and future events will be expected to generate less erosion.
