# VOLUMES AND NUTRIENT CONCENTRATIONS OF EFFLUENT PRODUCTS GENERATED FROM A LOOSE-HOUSED WINTERING BARN WITH WOODCHIP BEDDING

Jane Chrystal<sup>a</sup>, Ross Monaghan<sup>a</sup>, Mike Hedley<sup>b</sup>, and Dave Horne<sup>b</sup>

<sup>a</sup>AgResearch, Invermay Agricultural Centre, Mosgiel, New Zealand

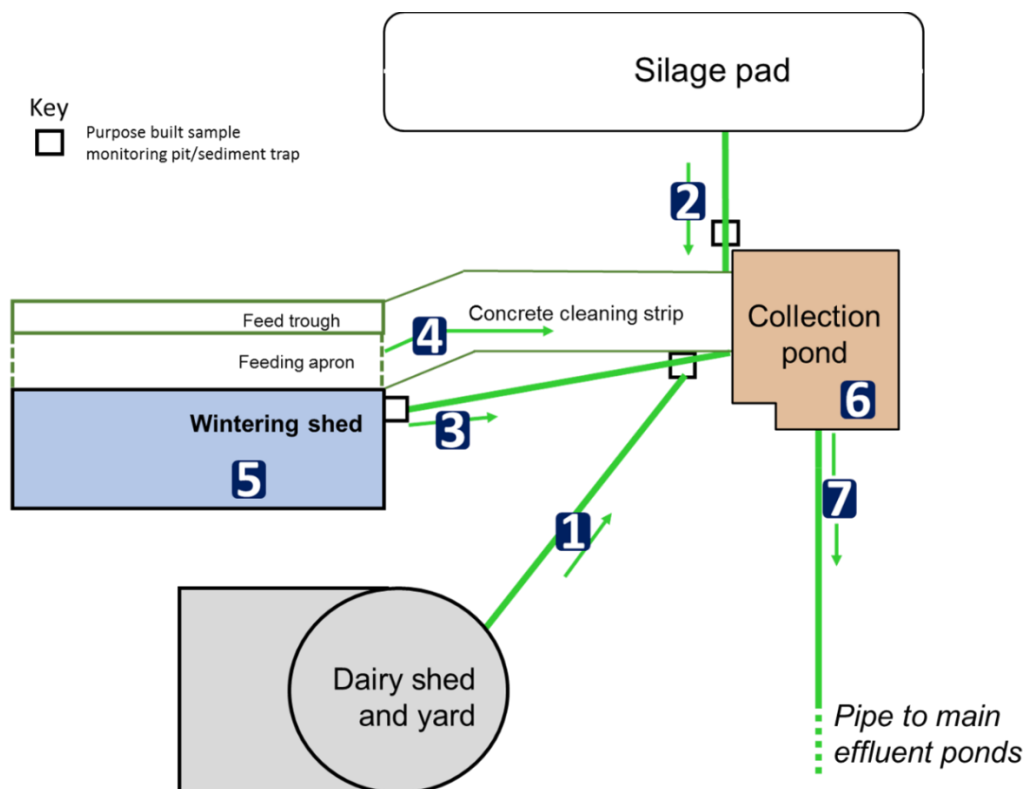
Figure 1: Diagram of the Telford farm effluent and manure measuring sites. These are: 1) FDE, 2) silage pad leachate, 3) effluent draining through the wintering barn bedding, 4) effluent scraped from the feed pad and concrete cleaning strip, 5) barn bedding, and 6) effluent collection pond. Effluent is then pumped via pipe ‘7’ to a large weeping wall for storage in the main effluent ponds.

*Monitoring sites (Figure 1)*

1. Monitoring of the FDE was via a sediment trap (location 1 in Figure 1) located near the collecting pond. This sump was used for spot sampling of effluent volumes and collections of effluent samples taken eleven times during the milking season.

2. Silage pad runoff volumes were recorded by a five litre tipping bucket connected to a Campbell logger located in a purpose-built sump area (location 2 on Figure 1). There was a collection container that collected 0.3% from each tip and stored it as a composite sample. This was analysed monthly.

3. To monitor the effluent draining through the barn bedding, a pit was located at the southern end of the wintering barn. This housed a three litre tipping bucket that was connected to a Campbell logger that recorded the number of tips the bucket made. There was a composite sample of effluent taken by syphoning 0.3% of each tip into a storage container. The container was emptied and a sample was sent for nutrient analysis on a weekly basis during winter and a monthly basis for the remainder of the year. The bucket was located at the base of the pipe that drained the wintering barn, which in turn drained to the collection pond (location 3 in Figure 1).

4. Effluent was scraped from the feeding alley (location 4 on Figure 1). This was monitored on three occasions carried out at different times during the winter. Here the material from the feeding alley was scraped to form a uniform pile at the end of the alley. The area of the pile was then calculated and a sample taken for analysis and estimate of bulk density.

5. Barn bedding was sampled for nutrient analysis when it was removed from the barn. The volume and number of loads removed were recorded (location 5 on Figure 1).

7. Estimates of the volumes of liquid effluent pumped from the collecting pond to the main effluent ponds were derived by an hour meter installed on the pump (location 7 on Figure 1). This was used to estimate the volume pumped. The hour meter reading was recorded weekly during the winter and less frequently during the milking season. Additionally, the volumes of solids removed by tanker from the pond were recorded as they occurred.

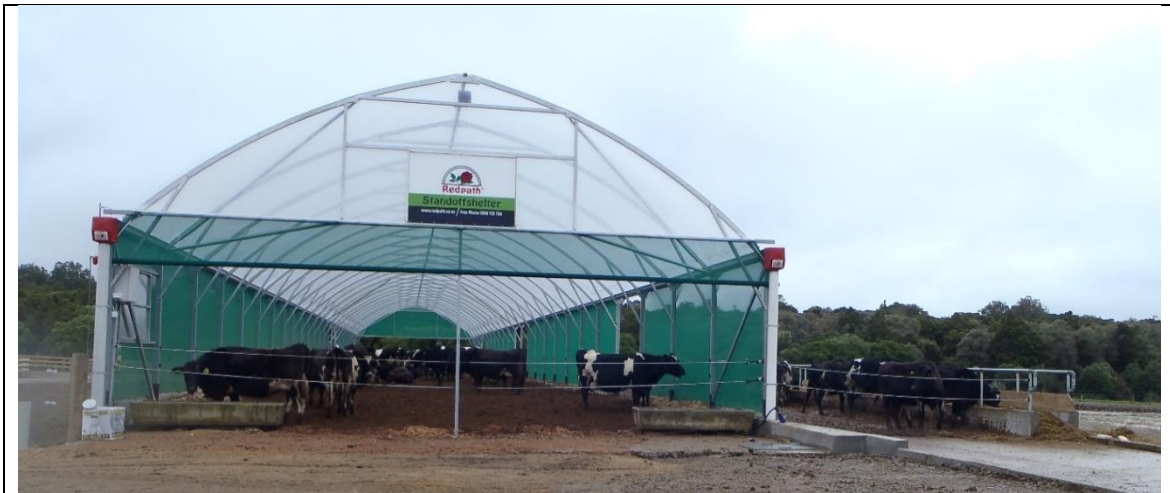
A. Wintering barn with feeding alley on the righthand side

Photos: Wintering barn (A) and purpose built effluent system consisting of a 50 m<sup>3</sup> collection pond (B) that contains a weeping wall with wider than normal slats (C)

The wintering barn is a Red Path Dairyshelter ([www.redpath.co.nz](http://www.redpath.co.nz); Photo A). It is a loose-housed barn with a clear roof and windbreak along 2 sides of the barn. The base of the barn is a compacted stone and clay layer that is designed to capture all urine excreted via either absorption in the bedding or draining via slotted piping to the effluent system. The bedding used in the barn for the duration of the monitoring was woodchip. Water troughs were located at the ends of the barn (Photo A), although in 2014 these were relocated away from the bedded area and onto the unroofed feeding alley adjacent to the barn.

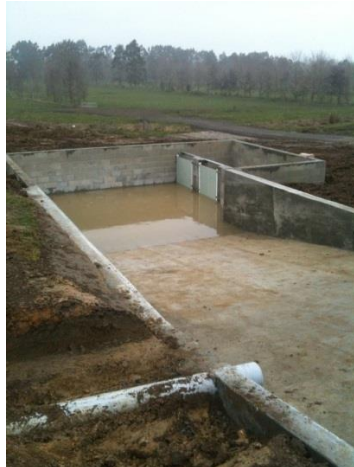
B. Purpose-built collecting pond

The liquid effluent from the wintering barn, silage pad and dairy shed are gravity fed to a small purpose-built collecting pond of 50 m<sup>3</sup> storage capacity (Photo B; Figure 1, point 6). The other source of effluent entering this pond is the solids and liquid effluent scraped from the feeding alley. Solids are scraped every one to two days during the times the barn is in use. The collection pond was designed with a weeping wall (Photo C) to screen out the larger fraction of solids. However, there were issues with the weeping wall blocking and this was

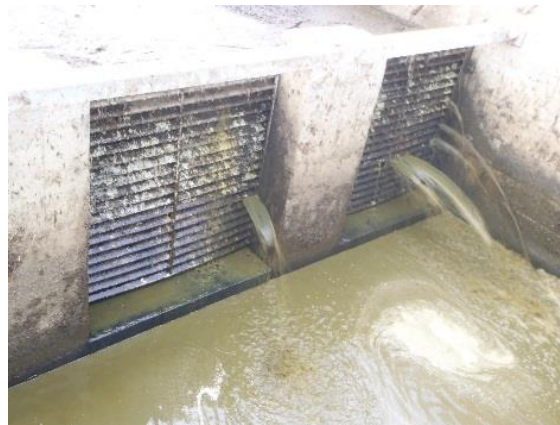
C. Weeping wall in collecting pond

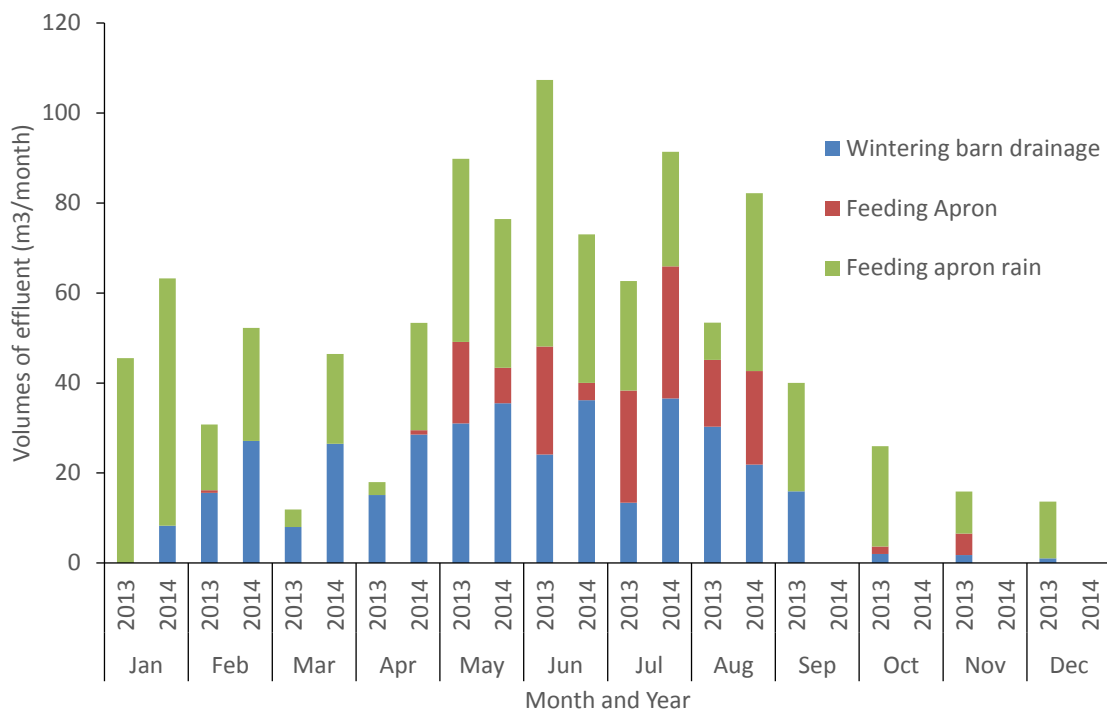
Figure 2: Total monthly volumes of the different effluent streams generated from the wintering barn over two complete winters of monitoring (2013 and 2014).

The total annual volume recorded from the wintering barn system in 2013 was 365 m<sup>3</sup>, of which approximately 158 m<sup>3</sup> came from the barn drainage, 89 m<sup>3</sup> from the feeding apron and the remaining 118 m<sup>3</sup> from rainfall on the feeding apron and scraping alley. In 2014, monitoring stopped at the end of August; the annual total until this time was 374 m<sup>3</sup>, of which 220 m<sup>3</sup> came from the barn drainage, 63 m<sup>3</sup> came from the feeding apron and 91 m<sup>3</sup> came from rainfall that fell on the apron and scraping alley. These volumes are shown on a monthly basis in Figure 2.

The results in Figure 2 highlighted a significant problem with the wintering barn drainage. The values recorded appear unrealistically high and there was drainage recorded when there were no cows in the barn. There are two possible reasons for this: firstly, the monitoring equipment could have been faulty. Secondly, there could have been extra liquid entering the wintering barn and thus the effluent system. Calibration of the monitoring equipment ruled out the first possibility. Analysis comparing daily rainfall with the daily volumes drained from the wintering barn (results not shown) showed a clear relationship between rainfall and leachate volume. Looking at one period of our results where there was a reasonable number of consecutive days where cows were housed for 24 hours a day and no rainfall was recorded

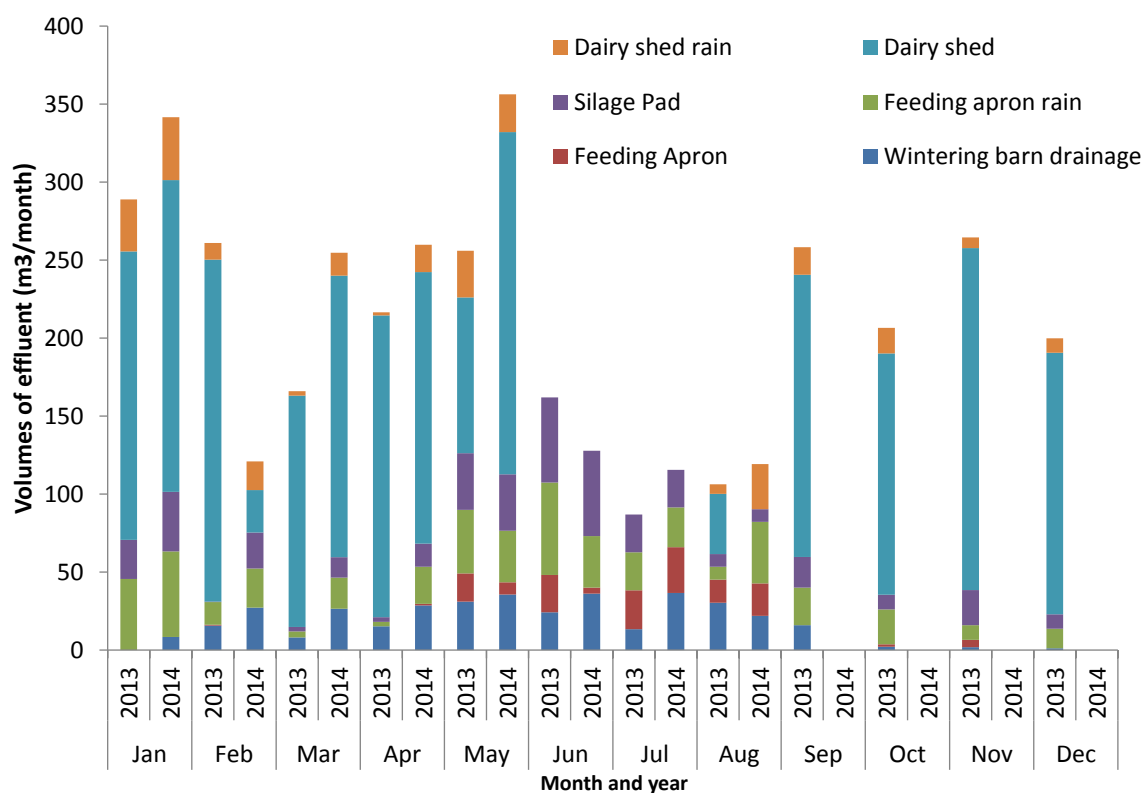
Figure 3: Estimates of the total volumes of effluent entering the Telford effluent collecting pond; scaled for the 110 cows of the RES herd.

Figure 3 shows all effluent streams entering the effluent pond system. This shows that the contribution from the three wintering barn streams was small relative to the volumes of FDE produced at the dairy shed. This volume reflects the volume produced by the 110 cows in the RES herd relative to the 750 cows being milked in the dairy shed.

The liquid pumped from the collection pond to the main FDE ponds was estimated by subtracting the volume of pond sludge removed from the collection pond from the total volumes of effluent entering the collection pond (Table 2). Dairyshed FDE produces the largest volumes of effluent captured by the effluent system (Figure 3).
